Preventing Moisture-Related Problems in Residential Wood Framing

Preservation treatments provide protection against the triple threat of mold, rot fungi and termites.

Provided by WoodSmart Solutions, Inc.

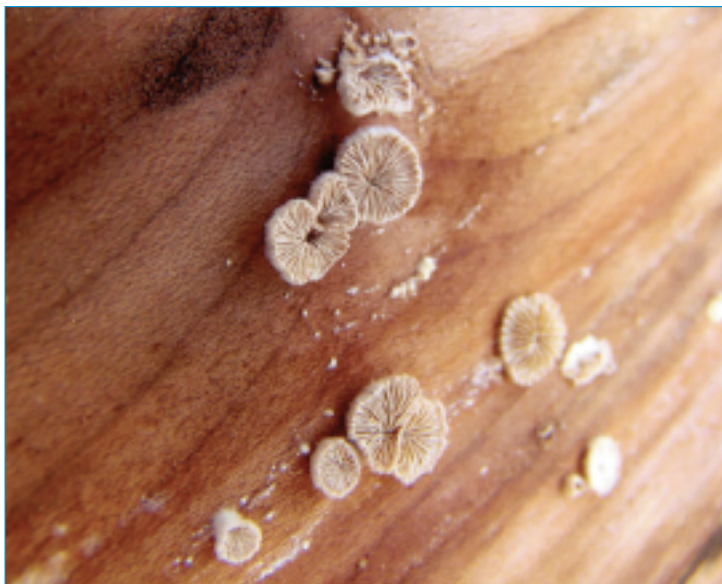
Some rot fungi can grow for long periods of time without producing any external evidence of internal destruction, while others produce visible fruiting bodies on the surface of decaying wood.

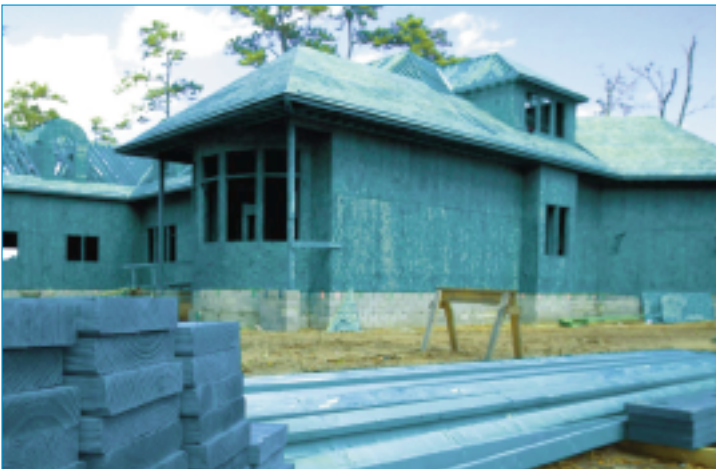
Wood components treated in the two-step process are considered non-hazardous, non-polluting, and non-carcinogenic per the limits of FIFRA, making them safe to use throughout a home.

With regard to the wood treatments described earlier, the two-step coating process has been reviewed by the EPA and is not regulated by FIFRA. The wood components treated in the two-step process, coated with a semi-vapor permeable film and DOT, are considered non-hazardous, non-polluting, and non-carcinogenic per the limits of FIFRA.

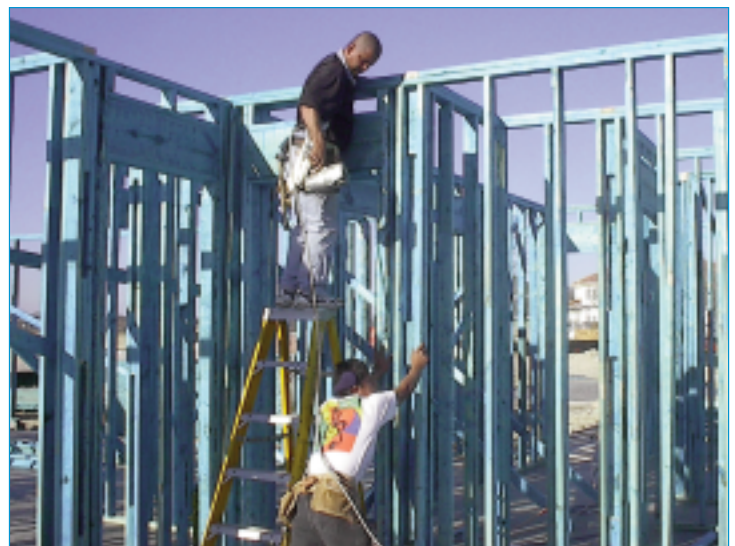
Wood that has been treated in the two-step process does not require any special handling. These components can be sawed, mechanically anchored, adhered, and painted just the same as untreated wood components.

Wood that has been treated in the two-step process does not require any special handling. These components can be sawed, mechanically anchored, adhered, and painted just the same as untreated wood components. The factory coating does not apply significant extra weight to the components either.
